For the Property at:
123 MAIN AVE
MY VILLAGE, NY 00000

Prepared for: JOHN HOMEOWNER
Inspection Date: Friday, June 13, 2014
Prepared by: John Hurst

Report No. 1007

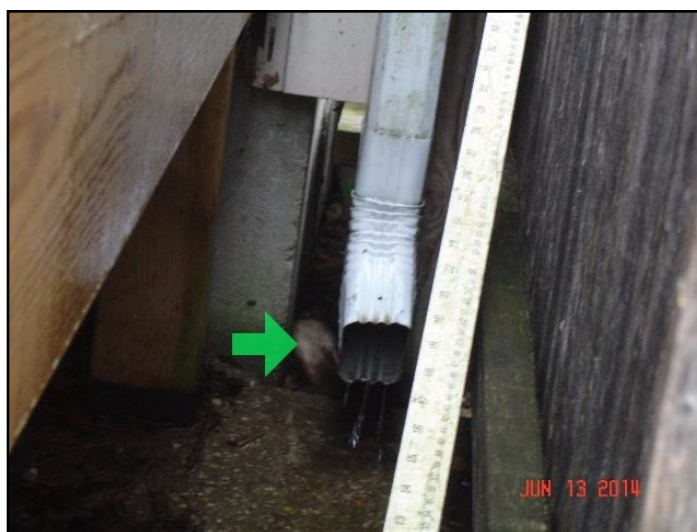
Condition: • [Downspouts end too close to building](#)

Implication(s): Chance of water damage to contents, finishes and/or structure

1. Downspouts end too close to building

Task: Improve

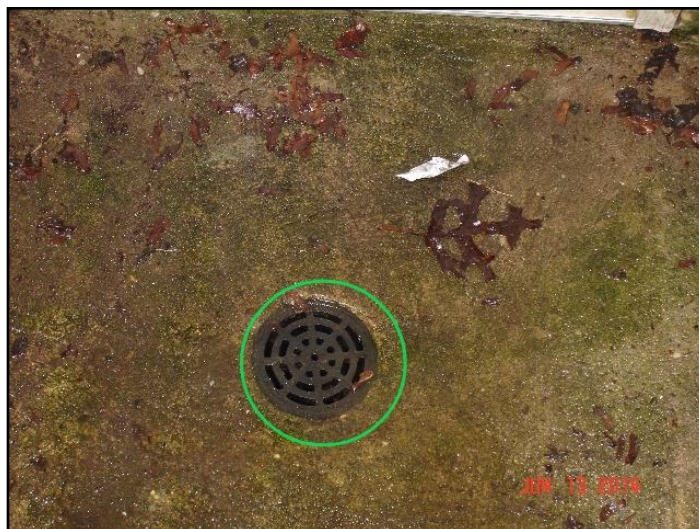
2. Drain

Condition: • [Drains missing, clogged or undersized](#)

Needs to be kept clear of debris for proper drainage

Implication(s): Chance of water damage to contents, finishes and/or structure

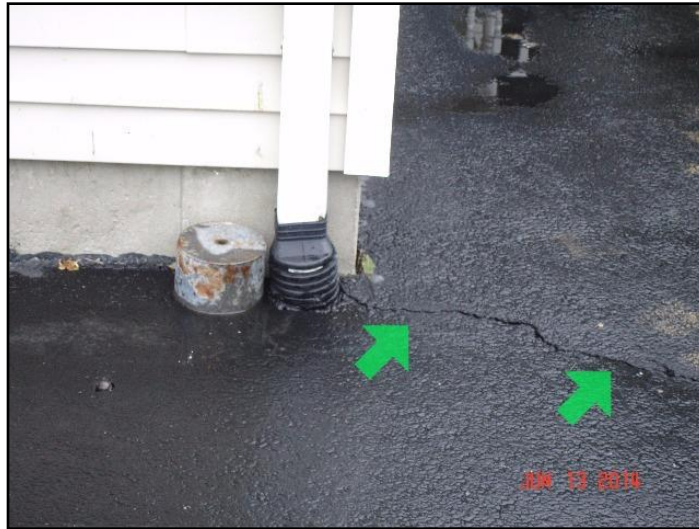
Condition: • [Cracked or damaged surfaces](#)

Implication(s): Trip or fall hazard

3. Cracked or damaged surfaces

Task: Further evaluation Monitor

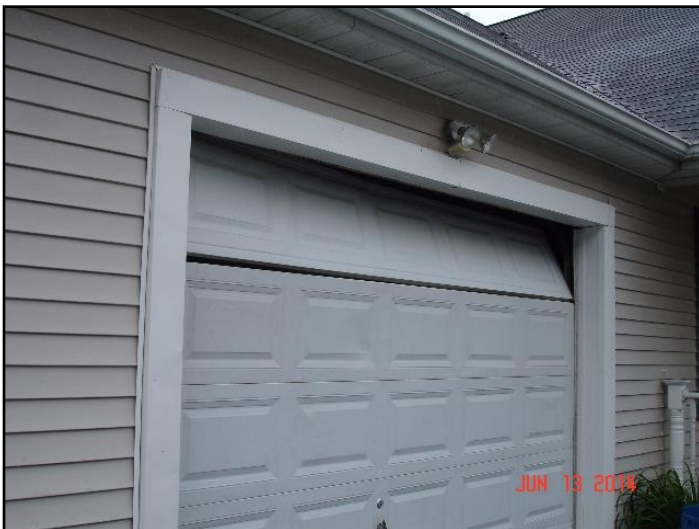
Condition: • Dented

Garage door in need of repair

4. Off track

Task: Repair

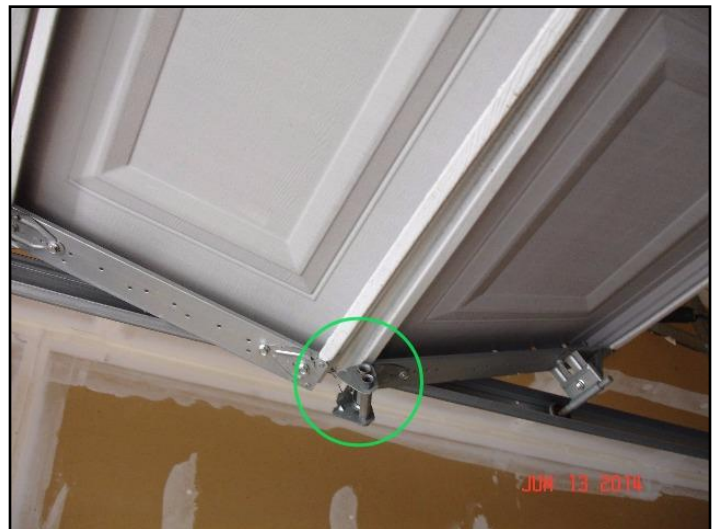
5. Off track

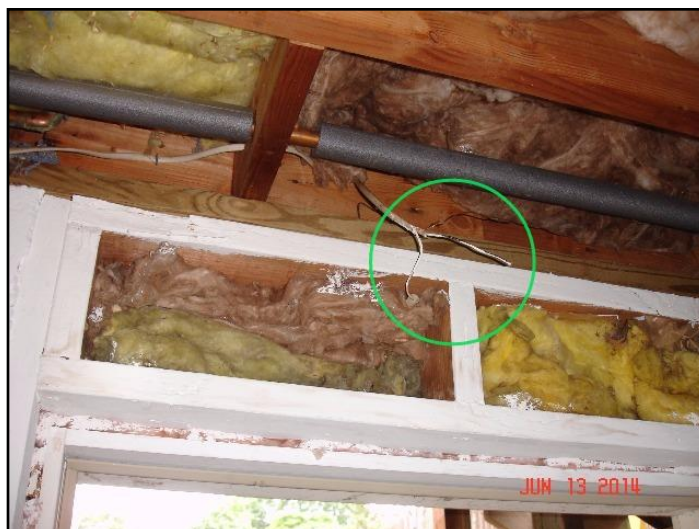
Condition: • [Exposed on walls or ceilings](#)

Exposed wire above basement entrance

Implication(s): Electric shock

6. Exposed on walls or ceilings

Task: Improve

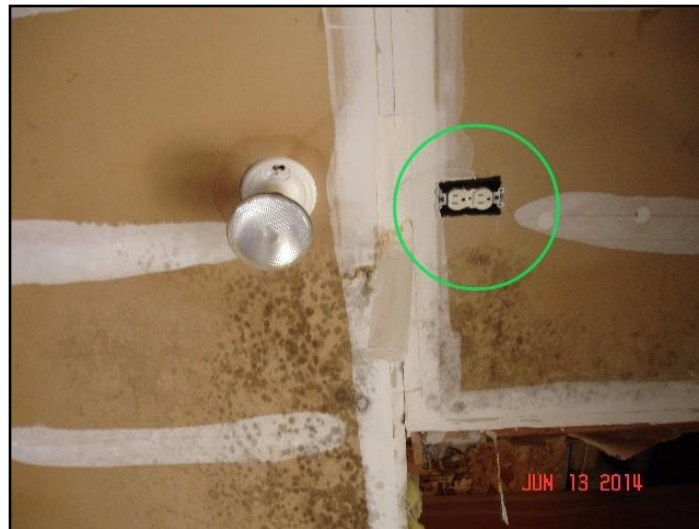
Condition: • [Missing](#)

Implication(s): Electric shock

7. Missing

Task: Provide

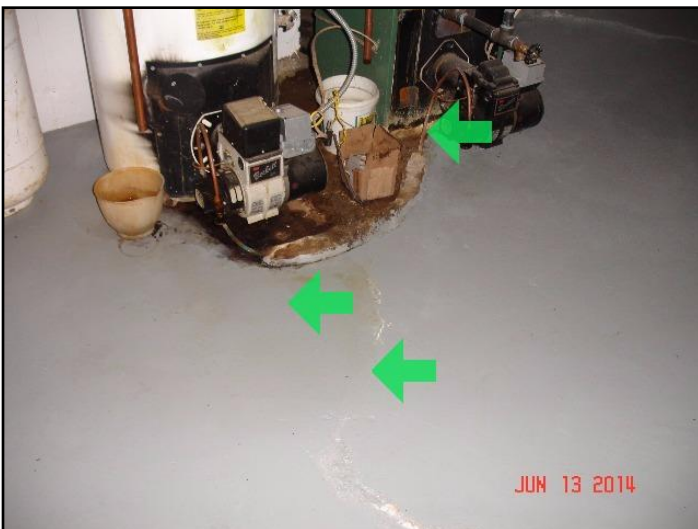
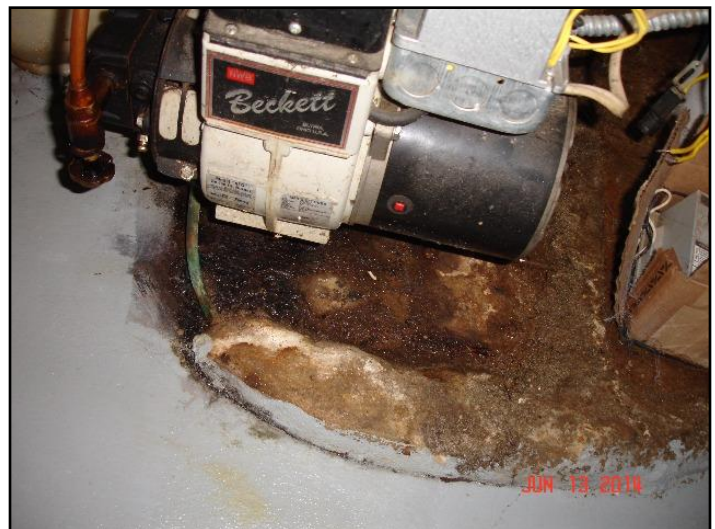
Condition: • [Medium failure probability](#)

Recommend further evaluation of heat and hot water systems due to age and appearance

Implication(s): No hot water

8. Medium failure probability

9. Medium failure probability

Task: Further evaluation

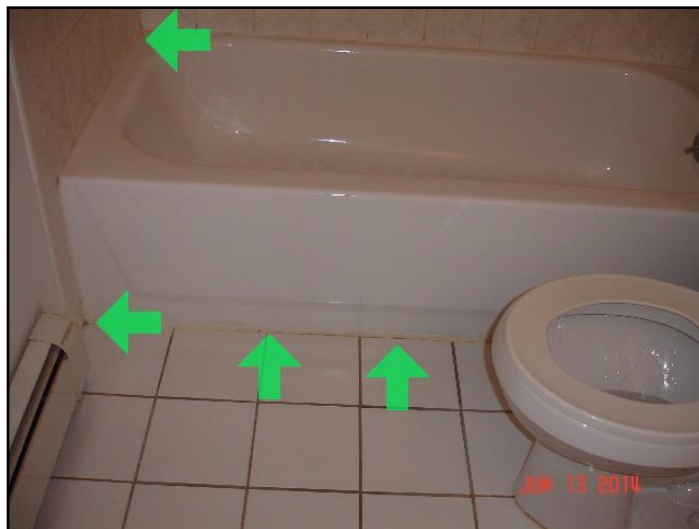
Condition: • [Caulking loose, missing or deteriorated](#)

Implication(s): Chance of water damage to contents, finishes and/or structure

10. Caulking loose, missing or deteriorated

Task: Improve

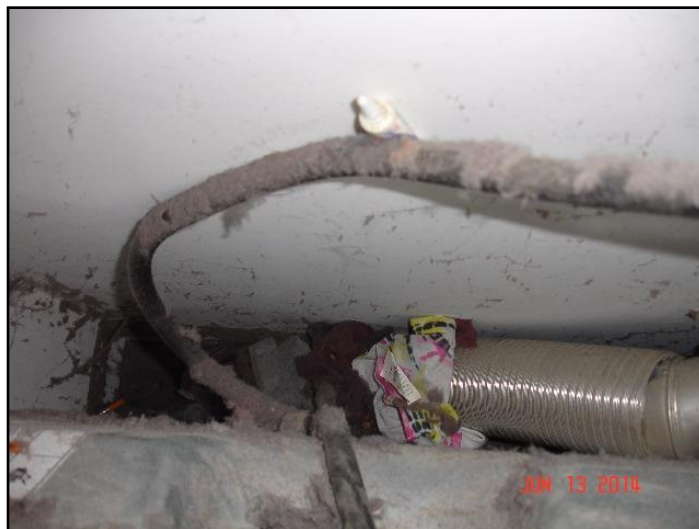
11. Rear of Dryer

Condition: • Excessive dust and flammables behind dryer

Implication(s): Possible fire hazard

Task: Clean Correct

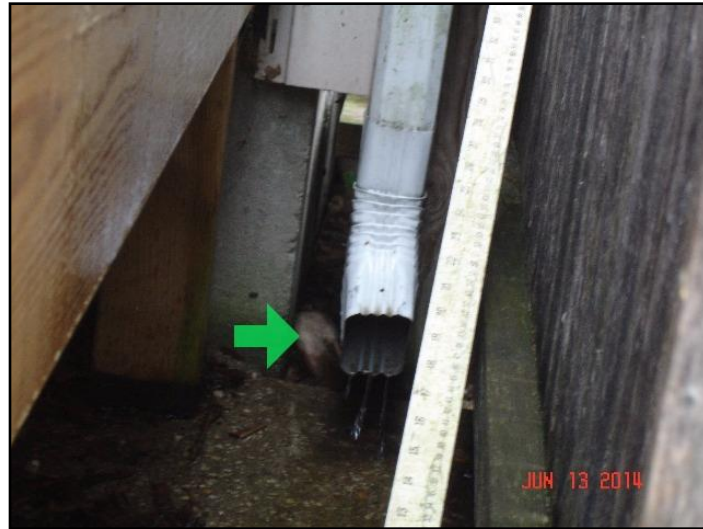
1. **Condition:** • [Downspouts end too close to building](#)

Implication(s): Chance of water damage to contents, finishes and/or structure

20. Downspouts end too close to building

Task: Improve

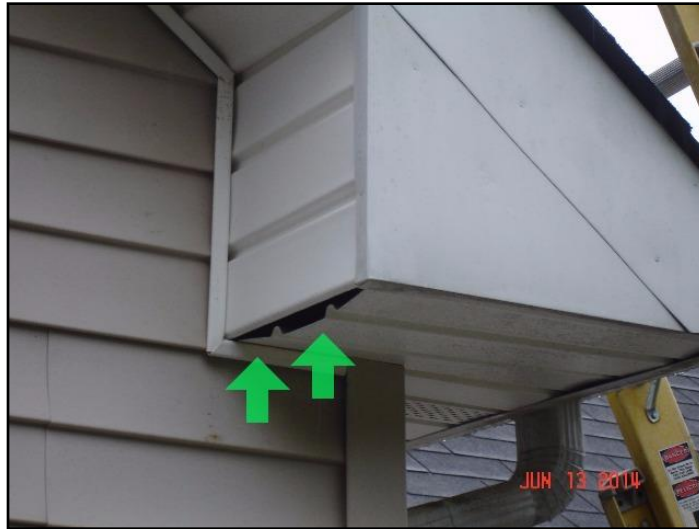
2. Condition: • [Loose or missing pieces](#)

Implication(s): Cosmetic defects | Chance of water damage to contents, finishes and/or structure | Chance of pests entering building

21. Loose or missing pieces

Task: Repair

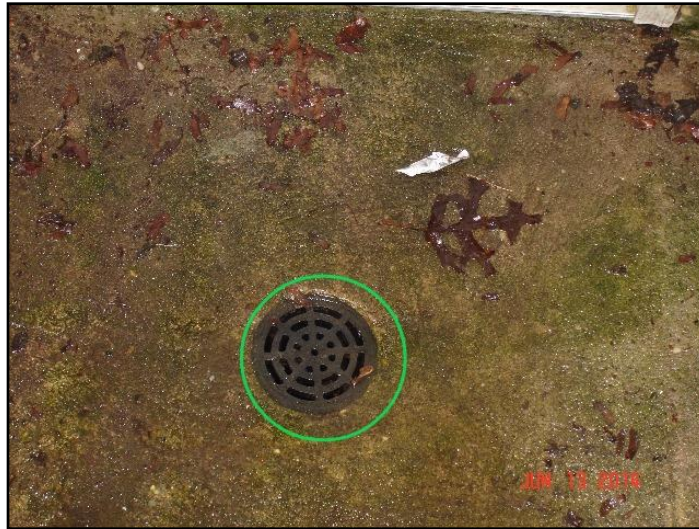
22. Drain

3. Condition: • [Drains missing, clogged or undersized](#)

Needs to be kept clear of debris for proper drainage

Implication(s): Chance of water damage to contents, finishes and/or structure

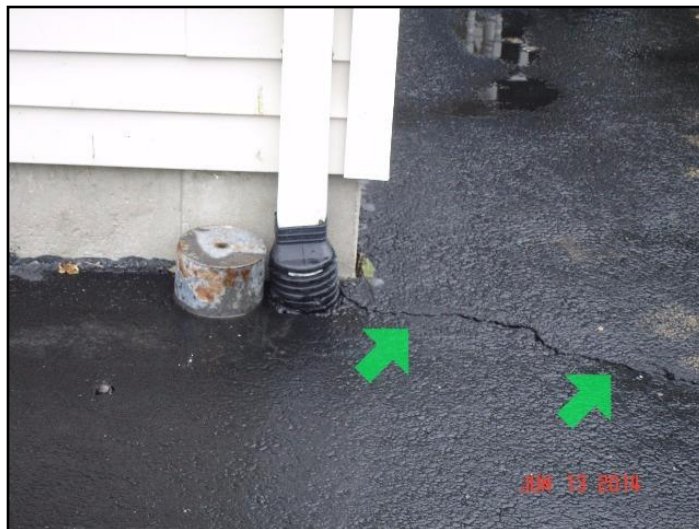
4. Condition: • [Cracked or damaged surfaces](#)

Implication(s): Trip or fall hazard

23. Cracked or damaged surfaces

Task: Further evaluation Monitor

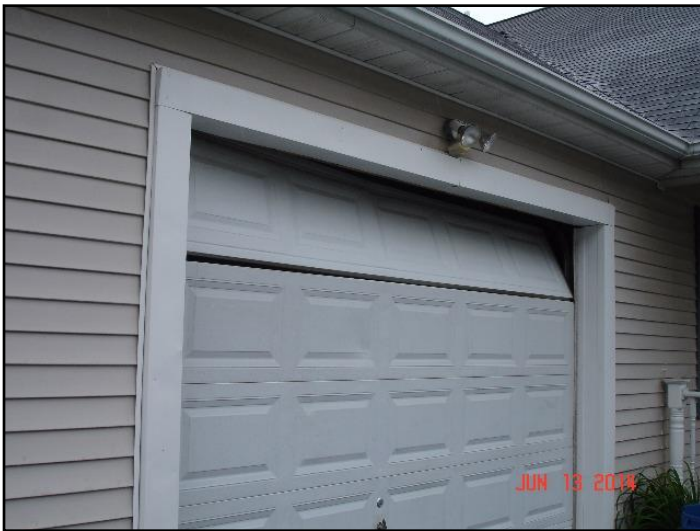
5. Condition: • Dented

Garage door in need of repair

24. Off track

Task: Repair

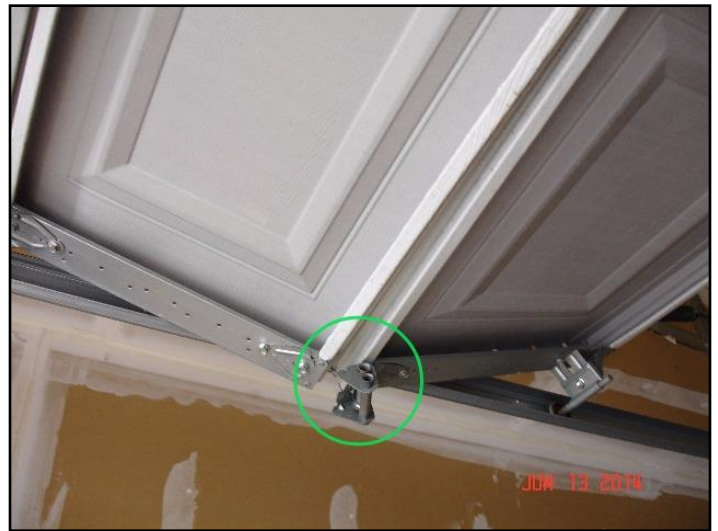
25. Off track

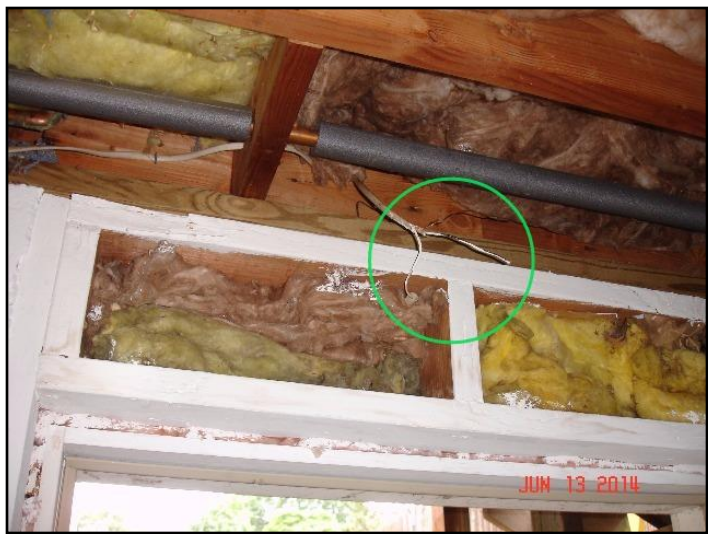
6. Condition: • [Exposed on walls or ceilings](#)

Exposed wire above basement entrance

Implication(s): Electric shock

38. Exposed on walls or ceilings

Task: Improve

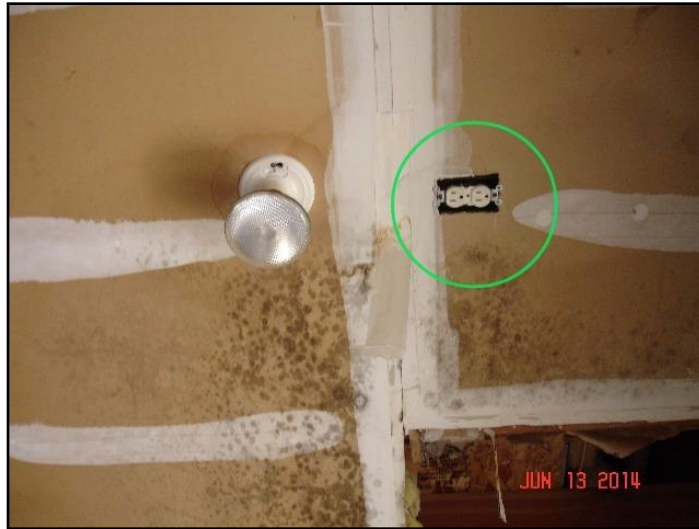
7. Condition: • [Missing](#)

Implication(s): Electric shock

39. Missing

Task: Provide

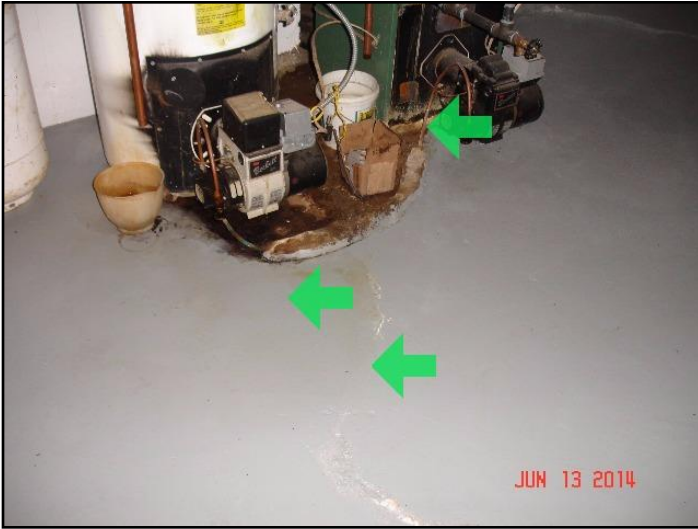
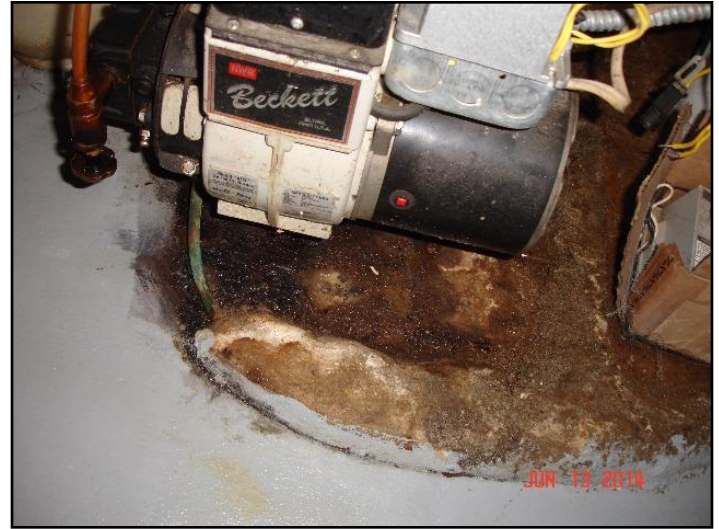
- 11. Condition:** • [Medium failure probability](#)
- Recommend further evaluation of heat and hot water systems due to age and appearance
- Implication(s):** No hot water
- Location:** Basement
- Task:** Further evaluation

47. Medium failure probability

48. Medium failure probability

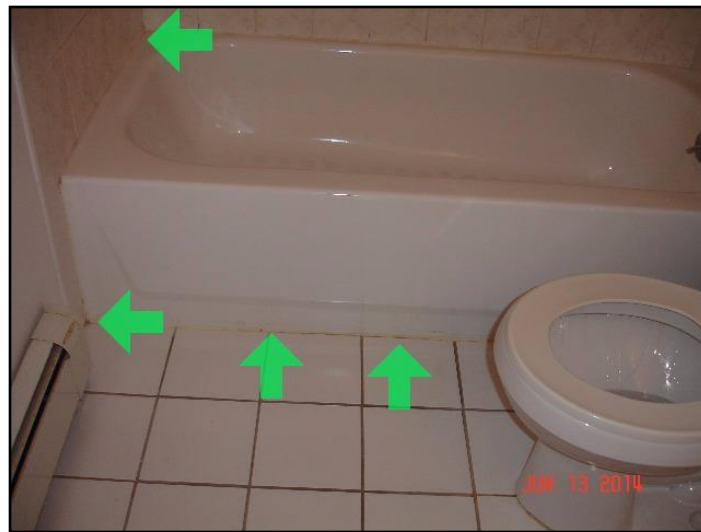
12. Condition: • [Caulking loose, missing or deteriorated](#)

Implication(s): Chance of water damage to contents, finishes and/or structure

49. Caulking loose, missing or deteriorated

Task: Improve

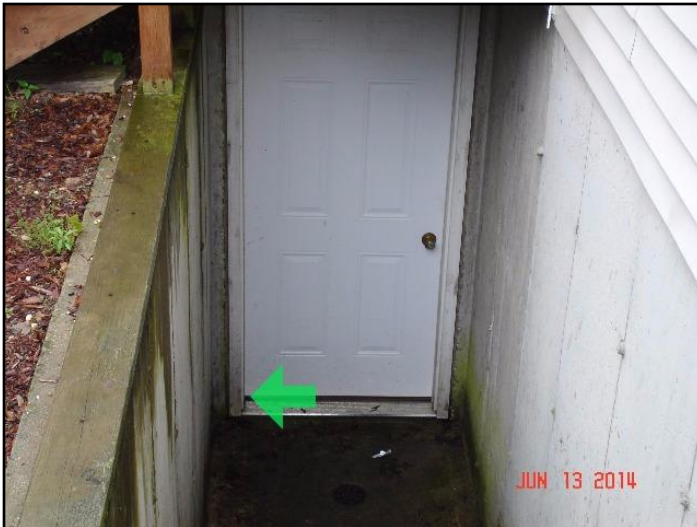
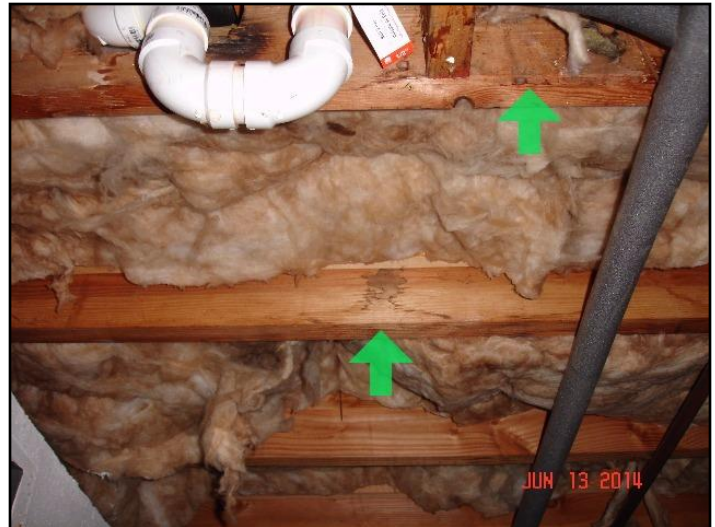
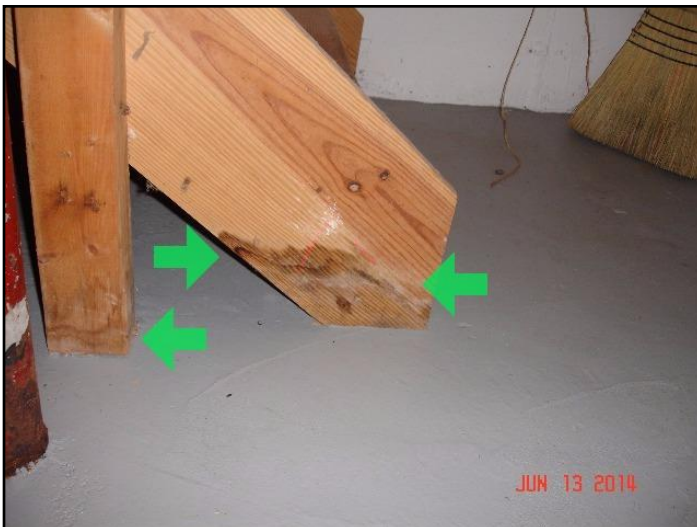
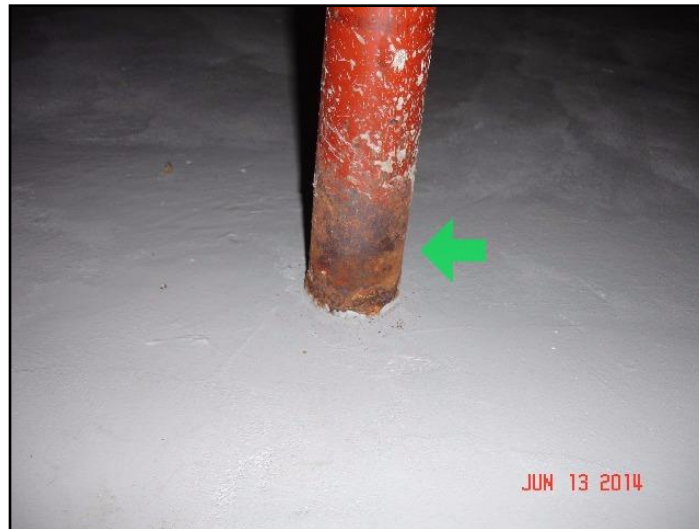
• Stains

Found prior water damage in basement and garage

50. Stains

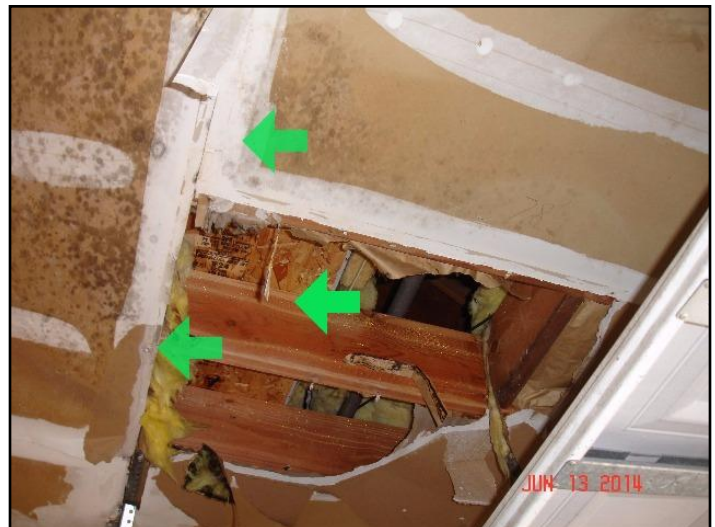
53. Stains Possible leak

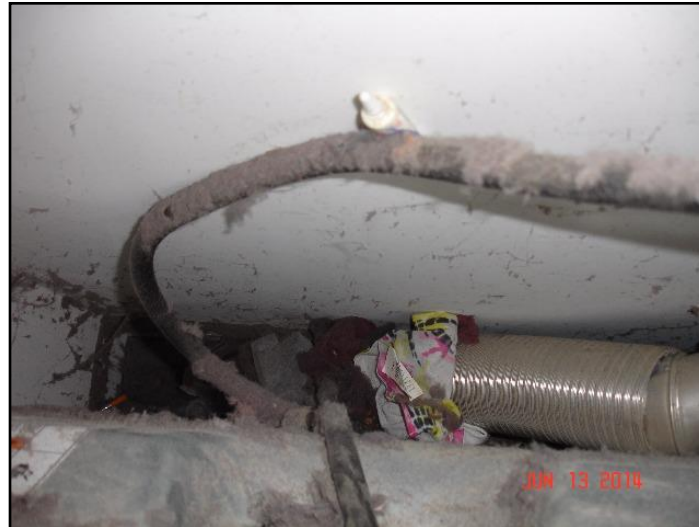
56. Rear of Dryer

13. Condition: • Excessive dust and flammables behind dryer

Implication(s): Possible fire hazard

Task: Clean Correct
