For the Property at:
123 MAIN AVE
MY VILLAGE, NY 00000

Prepared for: JOHN HOMEOWNER
Inspection Date: Friday, June 13, 2014
Prepared by: John Hurst

Report No. 1007

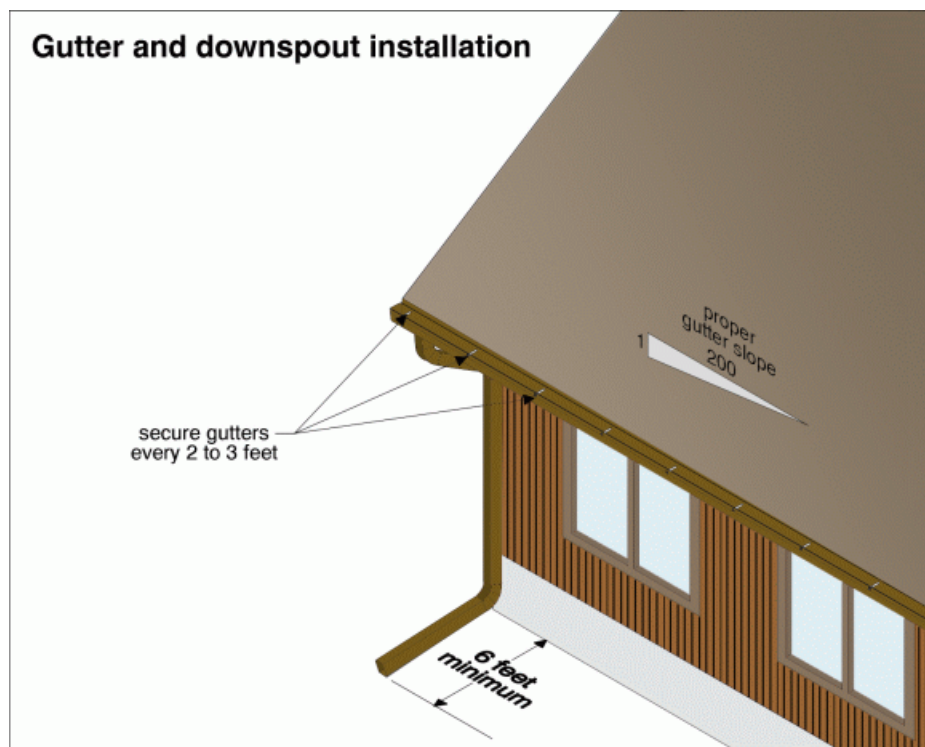
Condition: • [Downspouts end too close to building](#)

Implication(s): Chance of water damage to contents, finishes and/or structure

Location: Various First Floor

Task: Improve

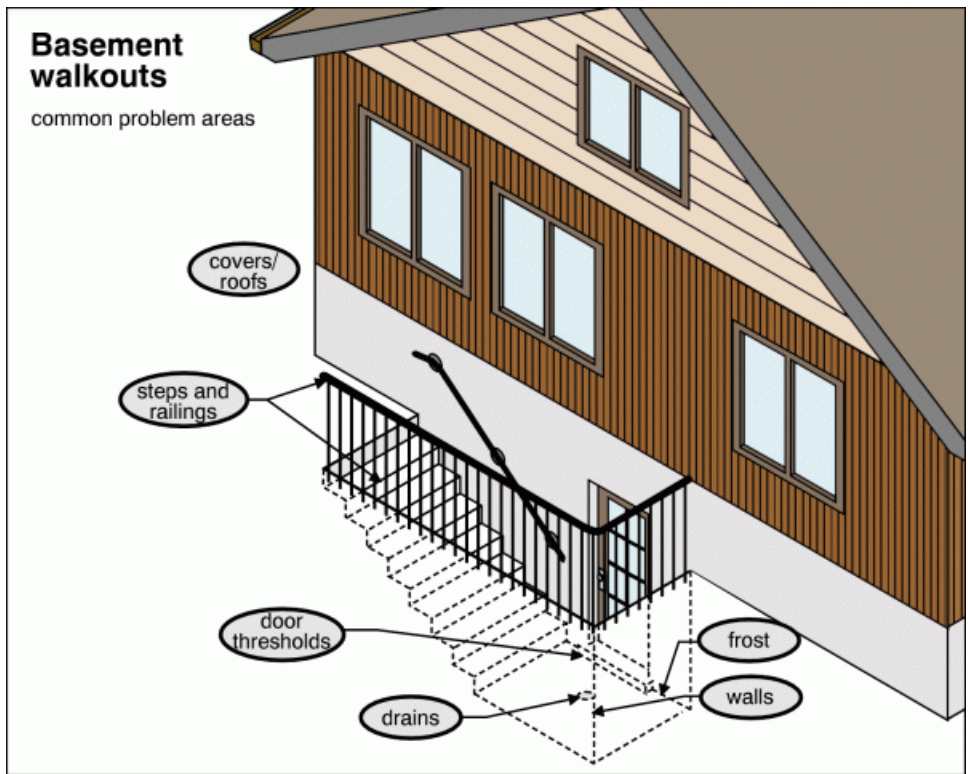
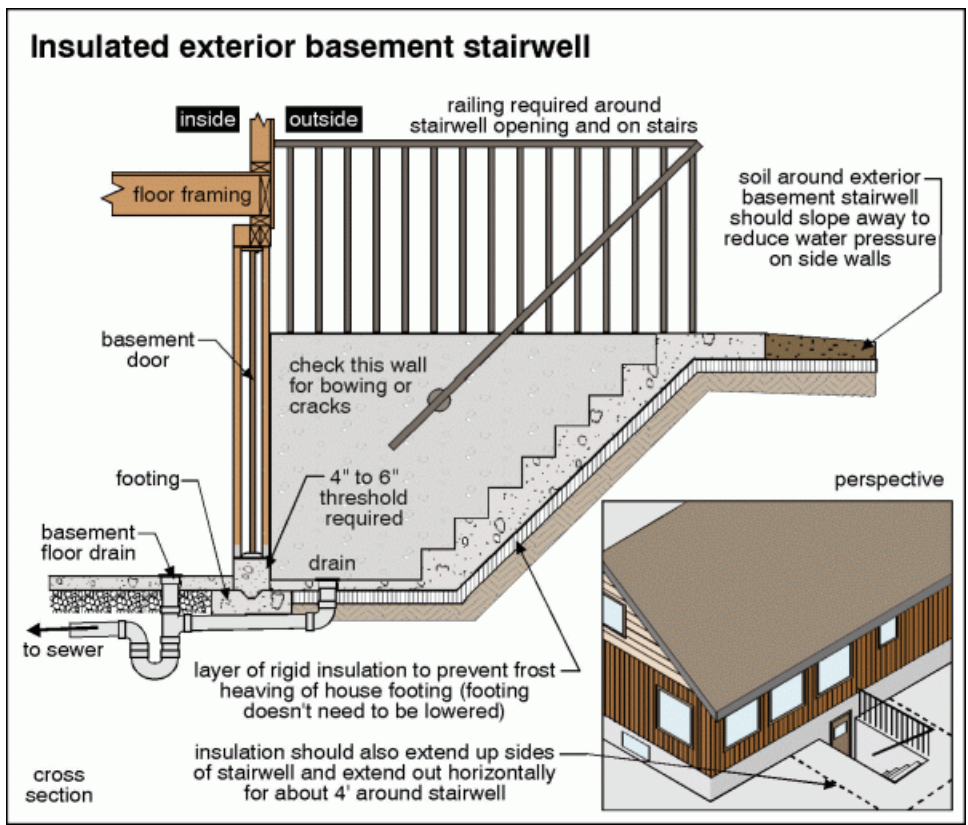
Condition: • [Drains missing, clogged or undersized](#)

Needs to be kept clear of debris for proper drainage

Implication(s): Chance of water damage to contents, finishes and/or structure

Location: Basement

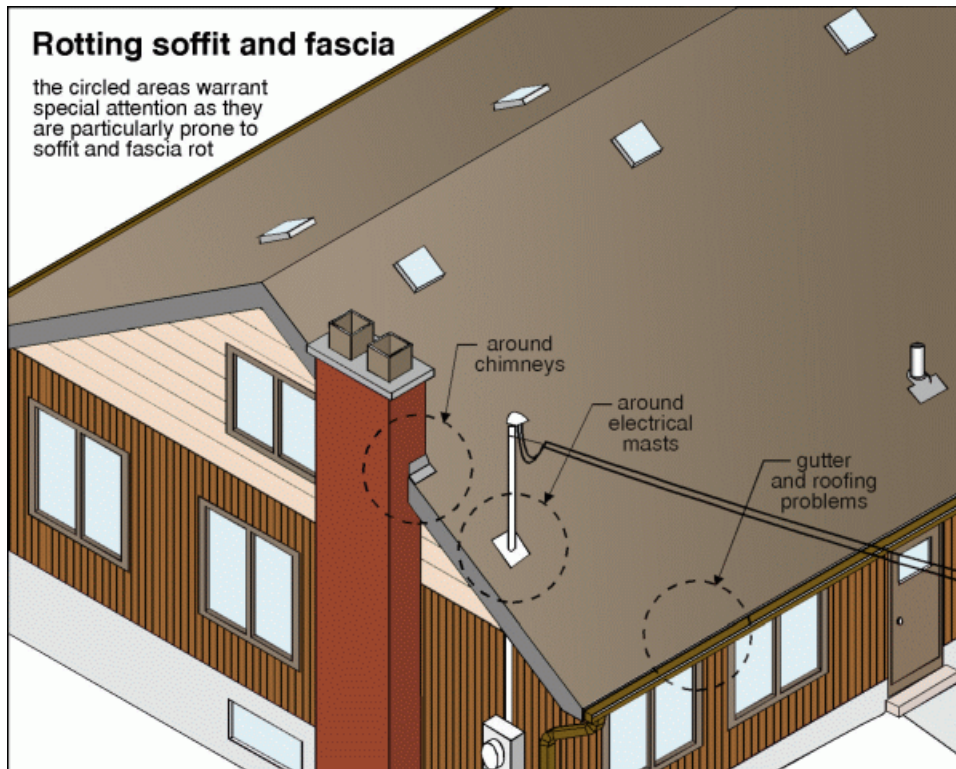
21. Loose or missing pieces

2. Condition: • [Loose or missing pieces](#)

Implication(s): Cosmetic defects | Chance of water damage to contents, finishes and/or structure | Chance of pests entering building

Task: Repair

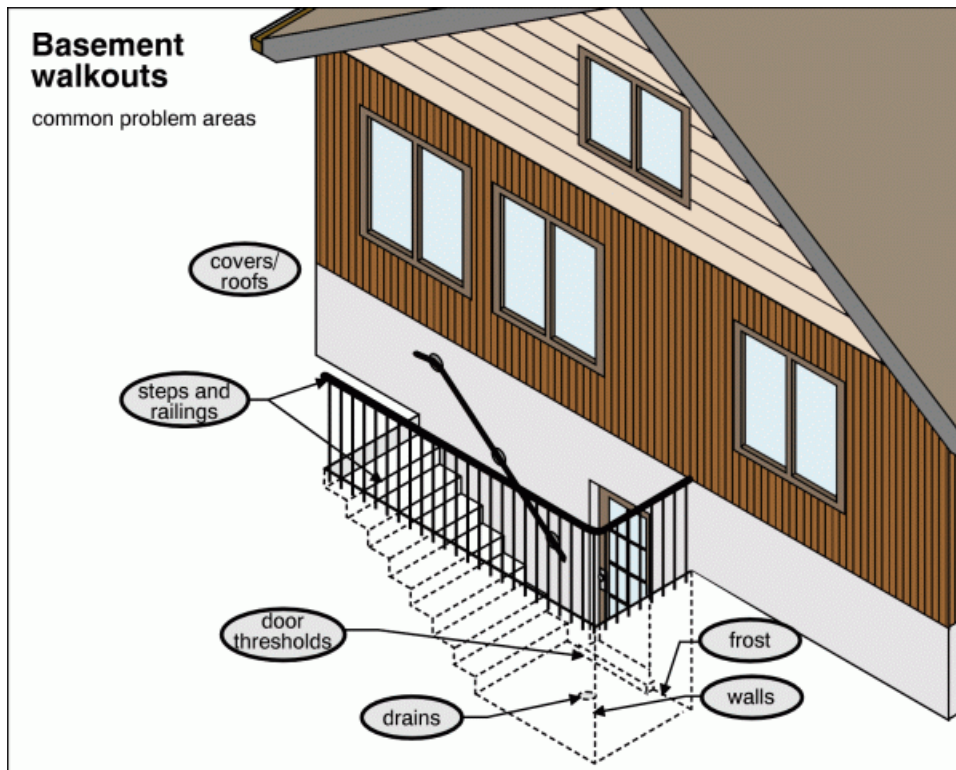
3. Condition: • [Drains missing, clogged or undersized](#)

Implication(s): Chance of water damage to contents, finishes and/or structure

Location: Basement
